# Deepwater Horizon Accident What Happened and Why?

**Roland N. Horne**  
**Thomas Davies Barrow Professor of**  
**Earth Sciences**  
**Stanford University**

January 3, 2011

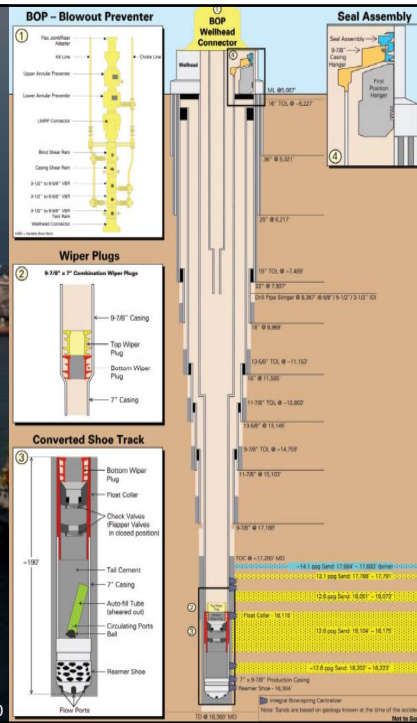
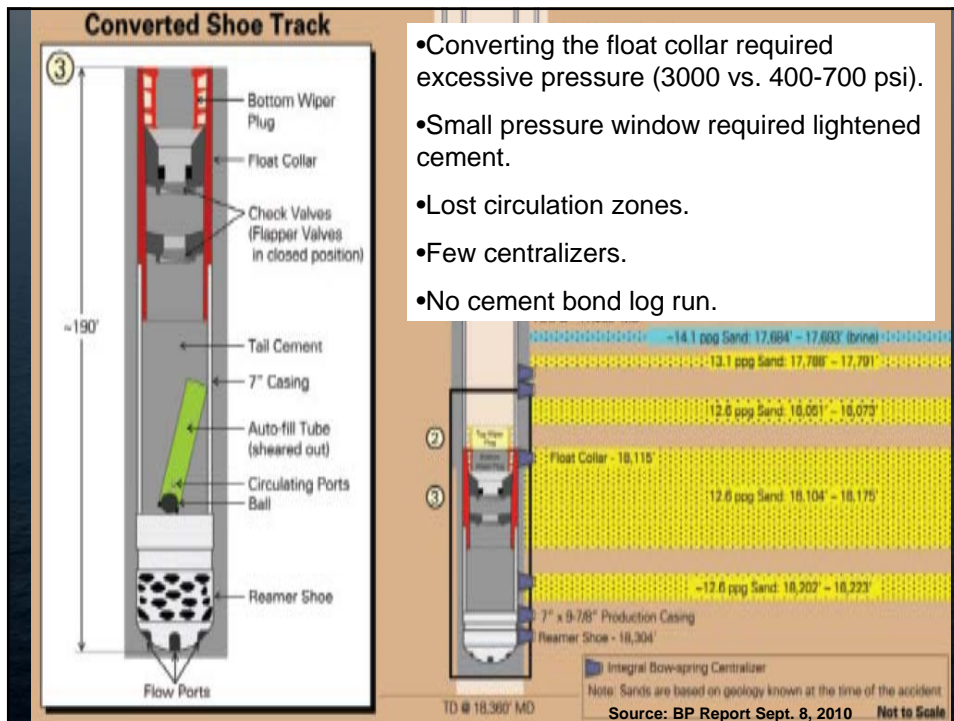
- There is no question that the cement job failed to isolate the formation.
- Unclear why. BP and Halliburton not in agreement.

- Converting the float collar required excessive pressure (3000 vs. 400-700 psi).
- Small pressure window required lightened cement.
- Lost circulation zones.
- Few centralizers.
- No cement bond log run.

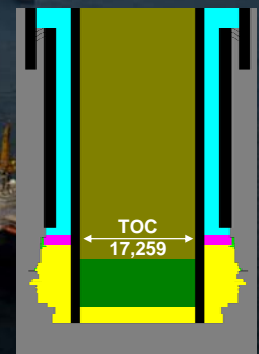
- Modeling indicated “severe” channeling could occur across the reservoir with only six centralizers installed
- Modeling was also run with 10 centralizers
- Channeling was still predicted
- Modeling was run with 21 centralizers
- No channeling was indicated
- Casing was loaded on rig with 6 centralizers
- 15 additional centralizers were flown to the rig, but were not to be used

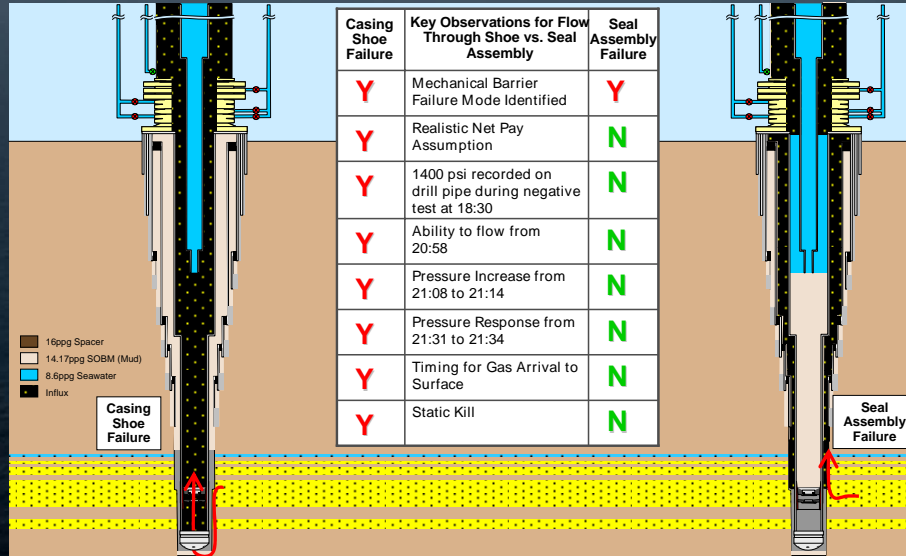
# Casing Shoe or Seal Failure?

1. It is clear that the cement job failed to isolate the producing formation.
2. It seems likely that the float collar check valves and shoe track cement failed to seal the casing.
3. The casing shoe can not be recovered from the well.

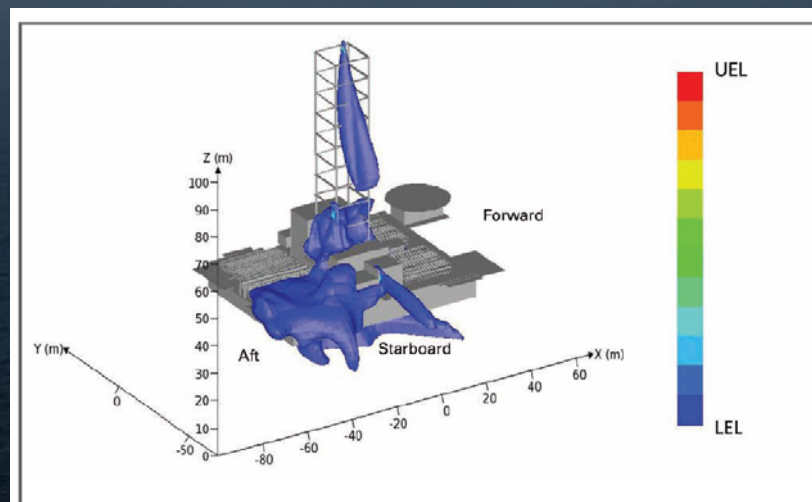
Figure 22. Vapor Dispersion Aft Deck—190 Seconds

- Gas was diverted to the MGS, instead of to the overboard diverter [BP].
- IBOP was not closed [BP].
- Engine room intake closure was not activated automatically on gas alarm [testimony].
- Engine overspeed → loss of power (and source of ignition?) [testimony]

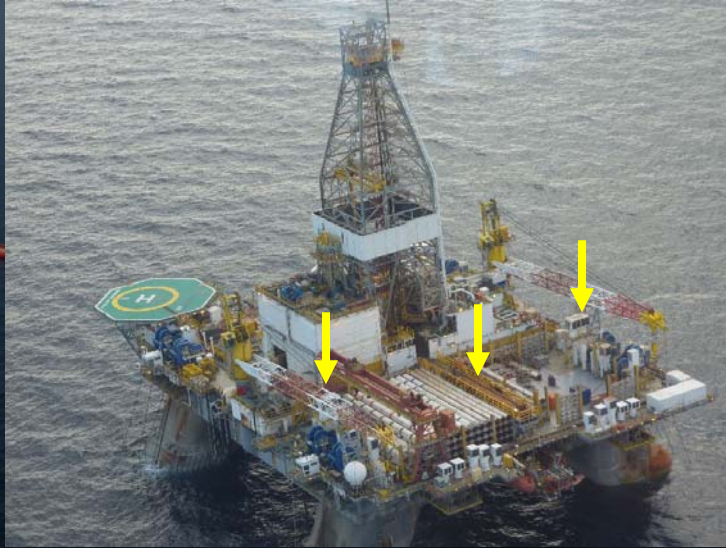
## Engine Intakes on Aft Deck

- BP Investigation Report:
  - “A flammable mixture was likely transferred into the engine rooms because the engine room HVAC fans were not designed to shut down automatically on gas detection.”
  - “There was a high level of reliance upon manual/human intervention in the activation of DH safety systems...”

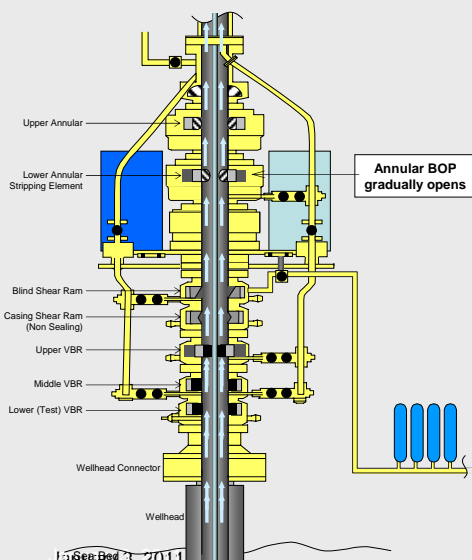
## BOP Response (Impact of Explosions)

- Damage to MUX cables and hydraulic line
  - Opening of annular BOP
- Rig drifted off location
  - Upward movement of the drill pipe in the BOP

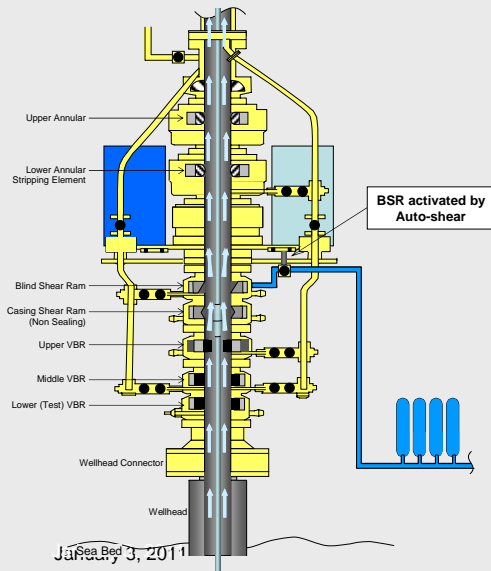
## BOP Response (After the Explosions)

- EDS attempts failed to activate BSR
- AMF sequence likely failed to activate BSR

- ROV hot stab attempts to close BOP were ineffective
- ROV simulated AMF function likely failed to activate BSR
- ROV activated auto-shear appears to have activated but did not seal the well

- Further ROV attempts using seabed deployed accumulators were unsuccessful

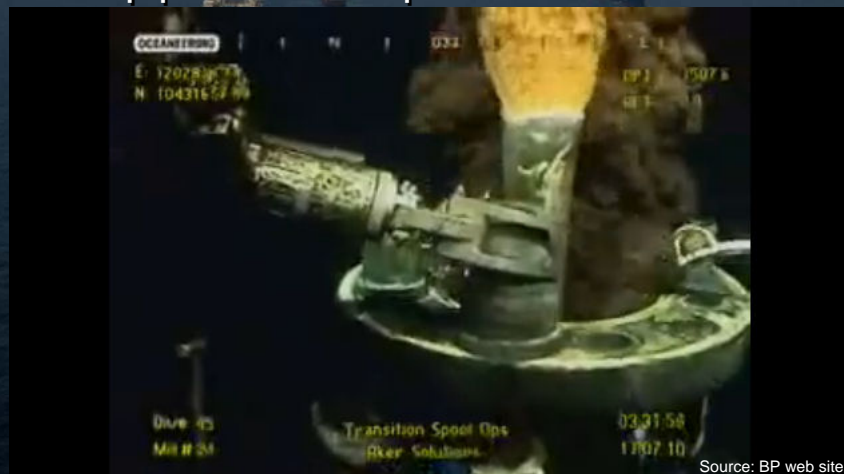
## BSR the Only Option

- Even if the annulus had been closed, the drill pipe was still open.

- A second blind shear ram (BSR).
- Independent BOP activation control (audio wave activation).
- More comprehensive data from BOP (position of rams, contents of tubulars).
- Real-time modeling of fluids and pressures in tubulars (as in simulations).
- Complete off-site transmission of data.

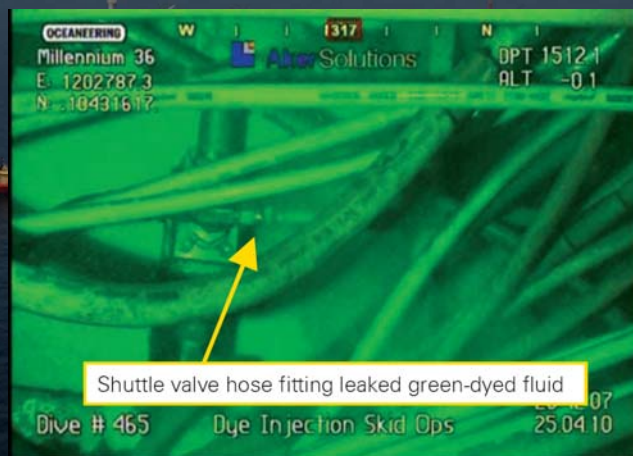
- Hydraulic leak on BOP

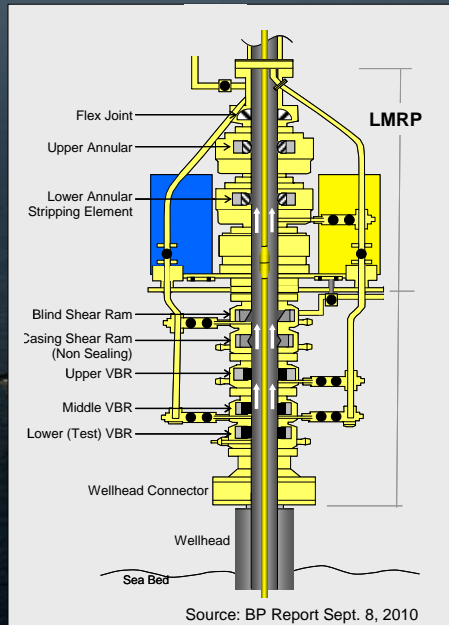
- BSR can only shear drill pipe – not tool joints, casing, or collars.
- BSR functioned by EDS(1), AMF and ROV.
- If tool joint in bore, cannot cut it.
